GAO

August 1998

DEFENSE INVENTORY

Action Needed to Avoid Inappropriate Sales of Surplus Parts

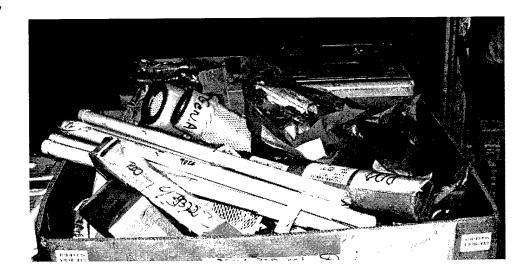
Figure 2: Batch Lot Containing Military Technology Items

DRMOS also inadvertently offered to sell some parts with military technology intact because DRMO personnel made errors in consolidating parts having military technology implications with parts not having these implications. This occurred when several single items were accumulated together and offered for sale as a batch lot. Although the batch lot was recorded as having no military technology implications, some individual parts in the lot contained protected military technology. For example, a batch lot of 42 weapons parts available for sale to the public at the Kaiserslautern DRMO contained 7 parts with military technology that should have been destroyed (see fig. 2). DRMO personnel subsequently removed the military technology items from the batch lot. DRMO supervisors stated that action would be taken to educate personnel on the required content of batch lots and that supervisory checks of batch lot contents would be made periodically to ensure that no parts with military technology are included in future batch lots.

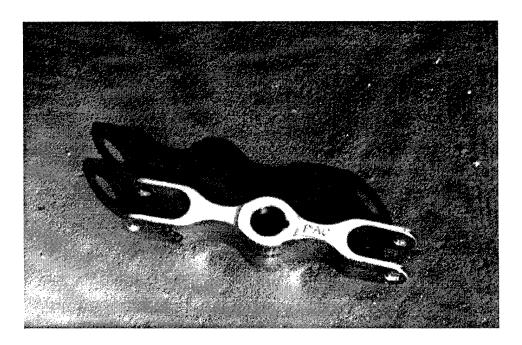
Figure 4: Tail Rotor Control Assembly

Also, in February 1998, the Kaiserslautern DRMO was offering for sale three tail rotor control assemblies used on the AH-1 Cobra helicopter (see fig. 4). If this part were to fail, the aircraft would spin uncontrollably and crash. The parts were not accompanied by required documentation stating it was safe to reuse them. DRMO officials said that they had not received any notification from the Army that this item had flight safety implications. Sales history information showed that this same part, described as being in severely worn condition, was sold in July 1996 by the DRMO in Columbus, Ohio, without any assurance that the part was safe to reuse.
